Distribution Centre for Retail Client

Over 350 Dialight LED High Bays installed at this 132,000m² Regional Distribution Centre (RDC) for a major global retailer.

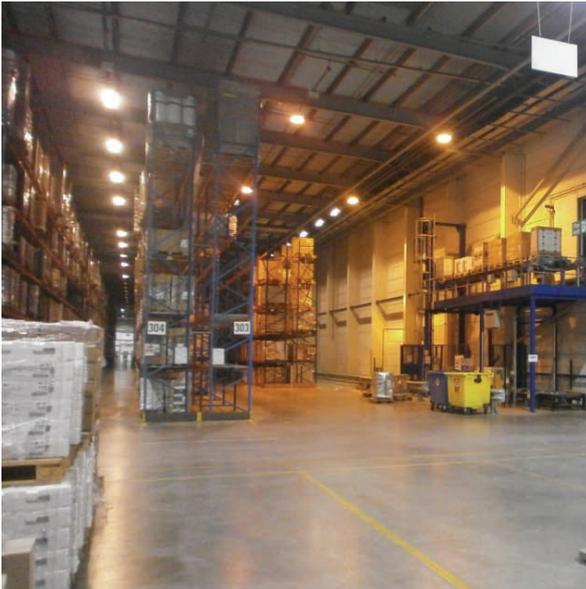
Before

At the time of build, this RDC was the largest facility of it's kind in the world with a total pallet capacity of 270,000. The site was installed with 400W SON High Bays throughout the warehouse space, which offered a poor orange light at around an average of 150 lux. The LED replacement project pitted two of the major LED manufacturers against one another to ascertain, reliability, durability, cost savings and lifespan of the products. During 2012 several different designs were compiled to model the LED luminaires, with a number of critical changes being applied, not least the average lux requirement increasing from 150 to 200 across the RDC runways.

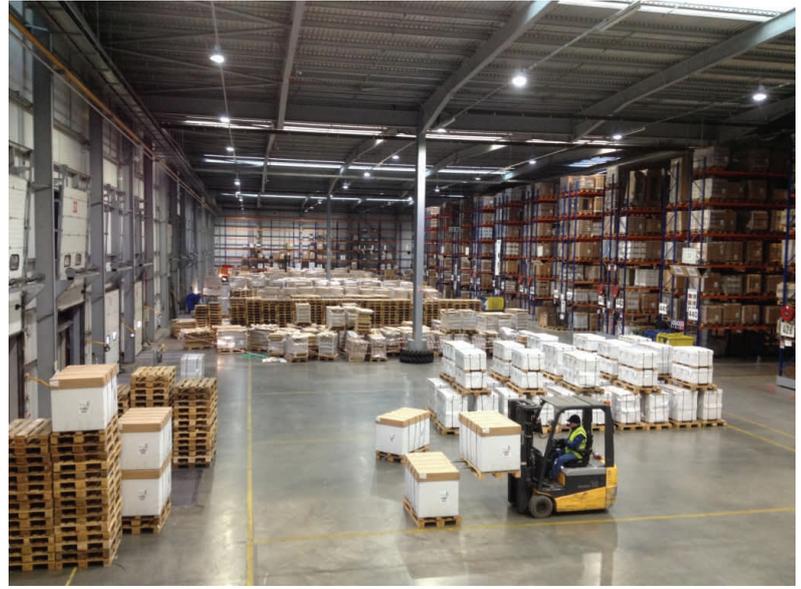
After

LED fittings – 357 x 250W Dialight LED High Bay

Mounting height – 11.5m

The client viewed the re-lamping exercise as an opportunity to increase and improve the lux values across the RDC, albeit the LED design required only the surrounding runways and loading bays to be covered with the new luminaires. The main racking areas retain the original 400W SON fittings, which will likely be changed in the coming years. The image above clearly demonstrates the differences in the quality of the light between the LED and Sodium fittings.
